# Manhole Inspection Summary

Manhole # S29A\_\_053MH

Insp Date: **3/12/08 2:02 PM**

**Location** Address: **INT.MARTIN LUTHER KING BLVD** Cross Street: **PENNSYLVANIA AVE**

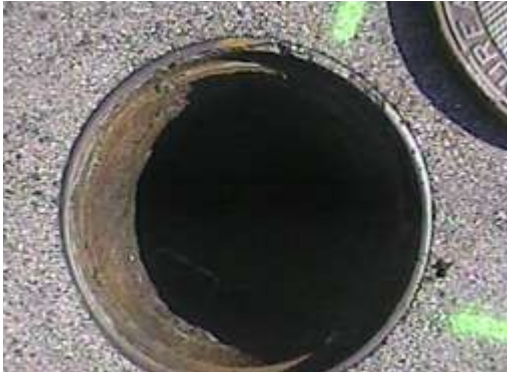
Top View

**Surcharge** ☒ **Evidence Of Surcharge** Depth: **4** (ft.) ☐ Active Surcharge Present

EVIDENCE OF SURCHARGE
